12TH INTERNATIONAL
BRICK/BLOCK
Masonry
CONFERENCE

**A STUDY OF SOME
DAMAGED ENCLOSURE WALLS**

Josep M^a Adell¹

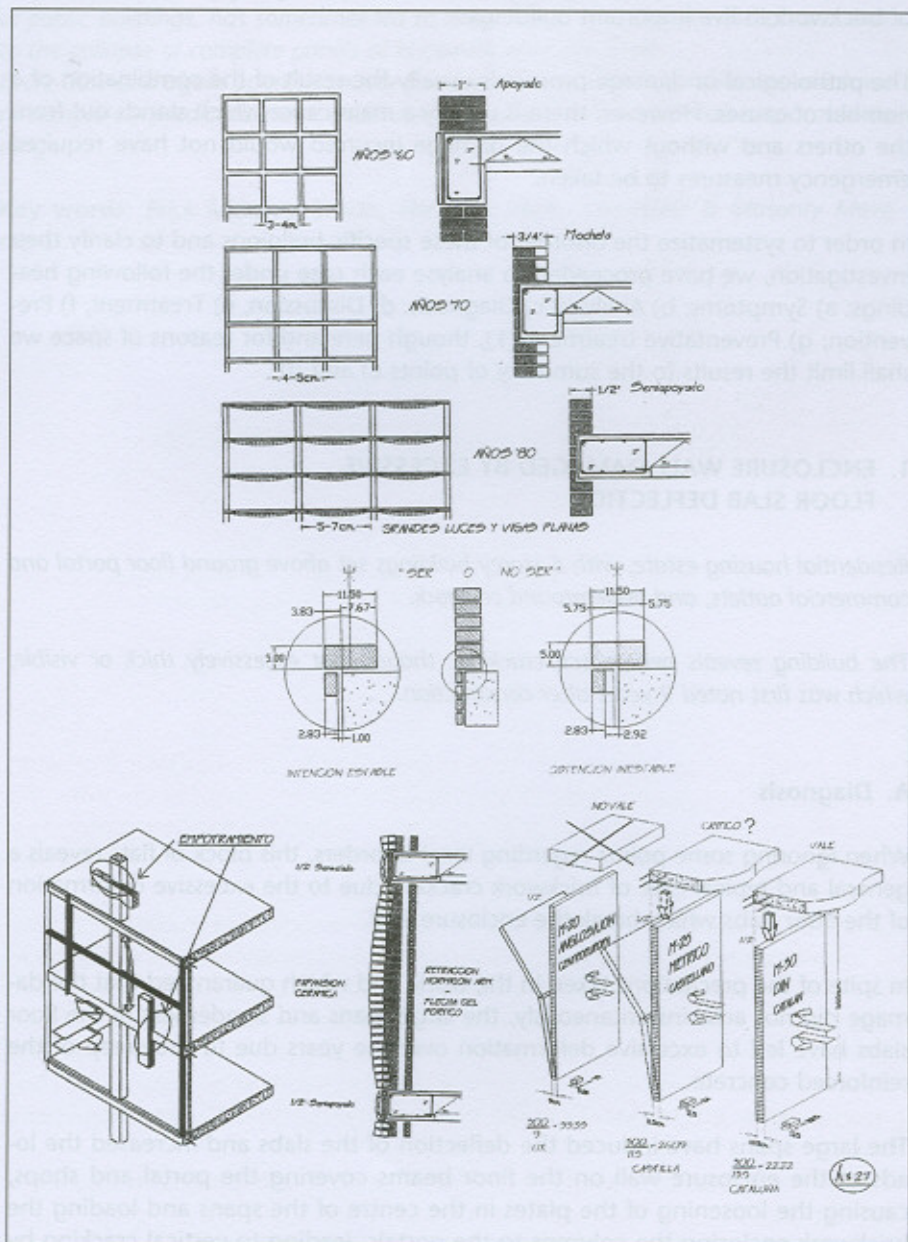
Figure 1. Subtle but fundamental changes in enclosure walls.

The 5 subtle but fundamental changes which have led to the current situation are as follows (Fig. 1):

- 1 The outer leaf of the enclosure walls has passed from one brick (24 cm) thickness to that of half brick thickness (11.5cm).*
- 2 The outer leaf is no longer supported in all its breadth but overhangs 4cm of its 11.5cm breadth.*
- 3 The framed structure of 4 to 5m span has been changed to one of 6 to 8m span.*
- 4 The edge beams of the structure have been replaced by flat beams.*
- 5 The recommendation to tie the walls to the foundations to obtain better stability.*

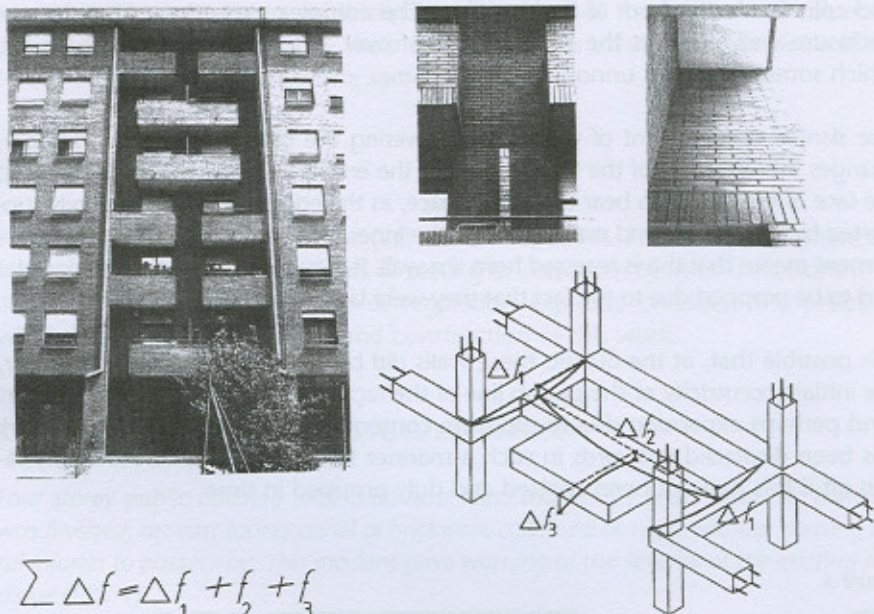
Figure 2.

When ignoring some points regarding local disorders, this block of flats reveals a general and typical case of brickwork cracking due to the excessive deformation of the floor slabs which break the enclosure wall.

In spite of the precautions taken in the work, and which guaranteed that the damage did not arise instantaneously, the large spans and slenderness of the floor slabs have led to excessive deformation over the years due to the creep of the reinforced concrete.

The large spans have induced the deflection of the slabs and increased the loads of the enclosure wall on the floor beams covering the portal and shops, causing the loosening of the plates in the centre of the spans and loading the brickwork enclosing the columns to the portals, leading to vertical cracking by shear stress.

The design of the building, and particularly that of the balconies, has led to an accumulation of successive deflection, between the overhang of the balcony and the recessed header façade beams, which has further aggravated the creep and led to horizontal cracking following the bed joint and 45° cracks which have broken the orthogonal masonry.

The brick breastwork has been pushed out by the longer facing brickwork, leading to almost complete lack of bed support and causing 45° cracking in the said brickwork. The expansion stresses of the longer panels of brickwork have accumulated in the corners, causing the vertical cracking of the brickwork at the corner supports.

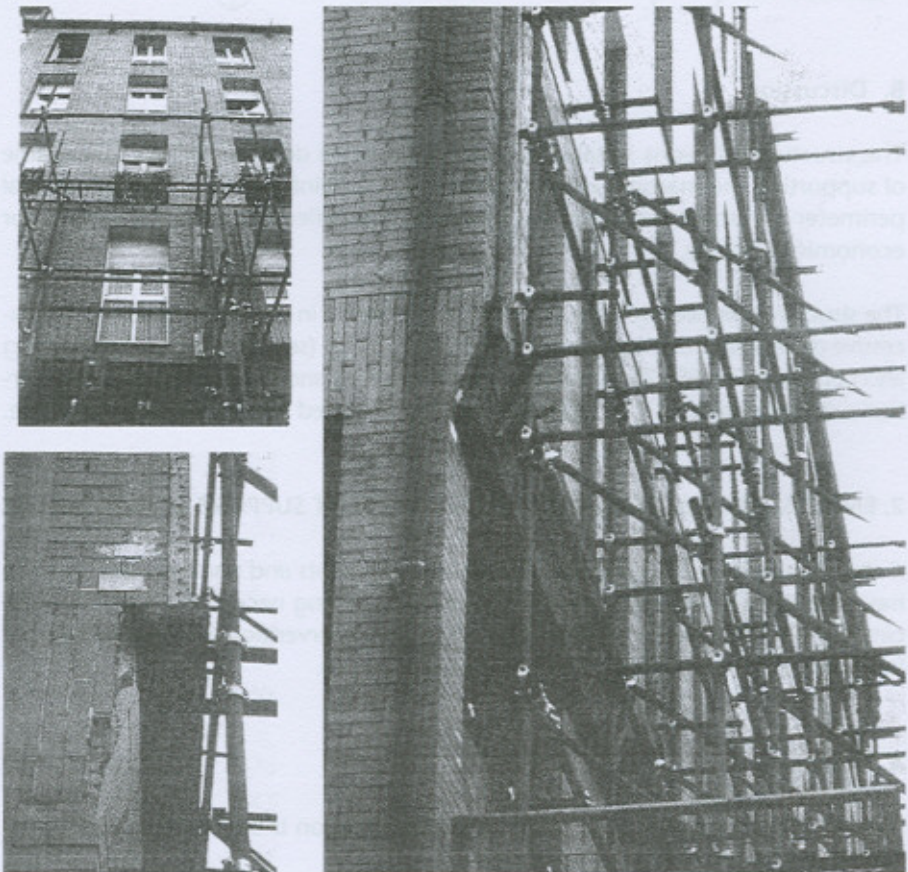
Figure 3.

5 storey housing block over shops and portals. Basements and garages. The building has general cracking in the area of the portals, it being necessary to prop two facing walls with threaten imminent collapse. This intervention was required only a few years after the building was completed (Figs. 3).

The structure does not reveal appreciable deformation though there is clear spalling of brickwork at the propped areas.

The 6" brick wall to the propped façades overhangs sufficiently to cover the slabs and columns in the form of flush walling. The complex execution of this type of enclosure wall, requires the cantilevering of over 1/3 of the width of the brick, which sometimes goes unnoticed.

The slanted arrangement of the rowlock covering the beam on the ground floor, changes the verticality of the load transfer of the enclosure wall and leads this down the face of the façade to bear on empty space, as the edge of the brick is barely supported by the beams, and even less so in the inner section when the slanting arrangement means that this is recessed from the wall. It may well be said that the façades had to be propped due to the fact that they were lacking an real support at the time.

It is possible that, at the outset, these walls did bear on their supports, however, the initial eccentricity of the plumb line of the façade with respect to the supports (and perhaps expansion due to moisture content) has meant that the brickwork has been displaced outwards in such a manner that it would have inevitably fallen off if this had not been spotted and duly propped in time.

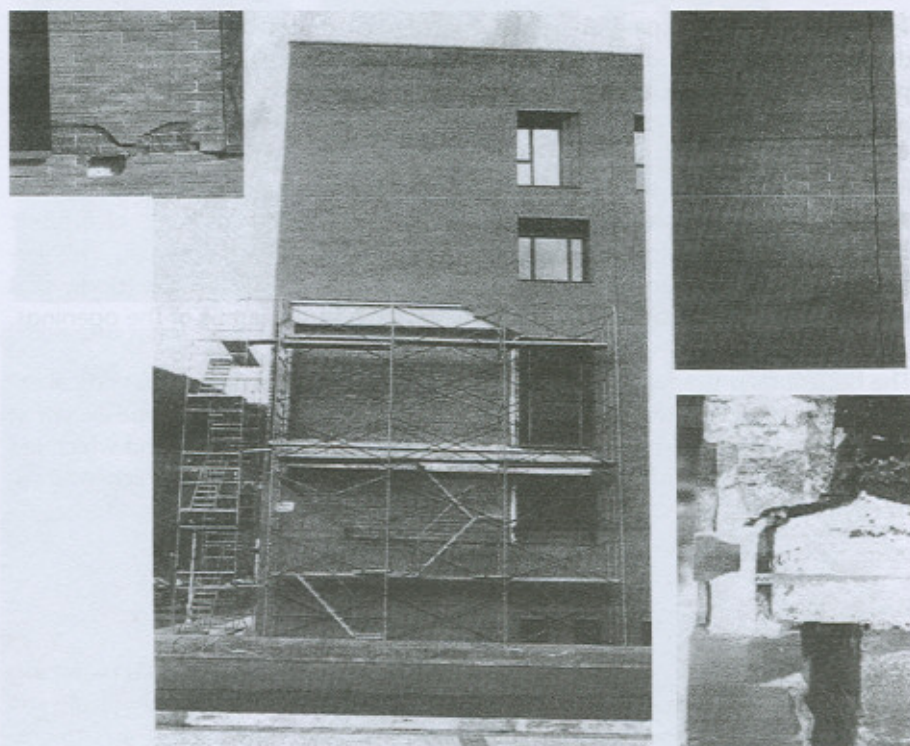
Figure 4.

Four storey public building with basement. Less than three years after the building was finished, an east facing panel of brickwork collapsed at night without causing fatal injuries to passers-by. This incident gave warning of the severity of the existing damage (Fig. 4).

The high moisture expansion which appeared in recent testing has been gradually produced throughout the life of the building and has led to the outer displacement or swelling of the wall from its supports in response to this natural expansion.

In a vertical direction the building has 17 metres of continuous brickwork with thin mortar joints which can barely absorb the increased thickness of a fabric which, in turn, has restricted vertical movement between each floor slab. This vertical expansion has led to the bowing of the brickwork which has vertically split the fabric in those areas of greater restriction such as the jambs of the openings.

The horizontal movement has been permitted as a result of numerous vertical expansion joints spaced every 9m, and this has prevented further damage except at the corners which were pushed by the longer panels of brickwork and which led to the displacement of the fallen unit from its original support, which was correctly carried out.

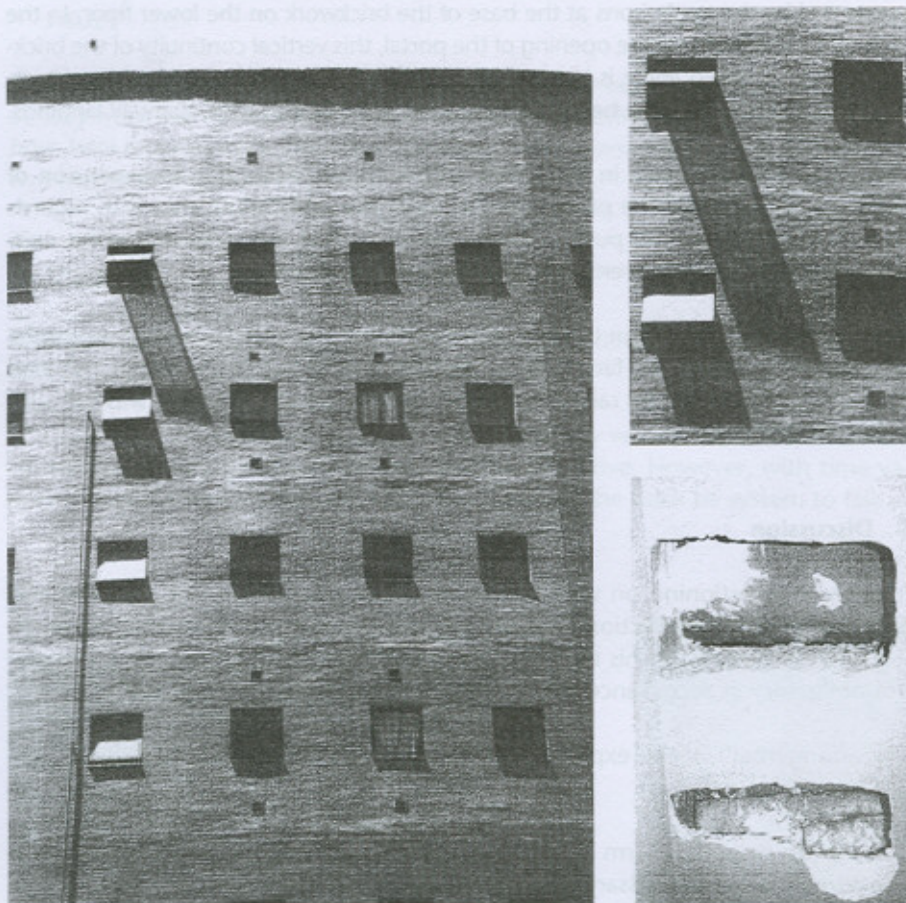
Figure 5.

The polygonal layout of the structural edge beams differs noticeably from the continuous curve followed by the 6" thick brick facing wall.

At certain points the brickwork runs completely free of the slab beams and is only supported by the angle irons at the base of the brickwork on the lower floor. In the area of the stairwell and the opening of the portal, this vertical continuity of the brickwork above the said angle is lost and the brickwork also fails to be suitably supported on the structural edge beams which run at mid-height of the stairway landings.

The continuing increases in the length of brickwork panels due to expansion of the brick has revealed the precarious nature of the said curved area with regards to their support, and has pushed the brickwork further outwards due to the existing curvature and has eventually destabilised the brickwork.

The structural shrinkage on the face of the slabs has marked the movement of the facing panels due to the fact that no horizontal movement joints were installed and as the brickwork was raised very soon after the structure which was still subject to shrinkage.

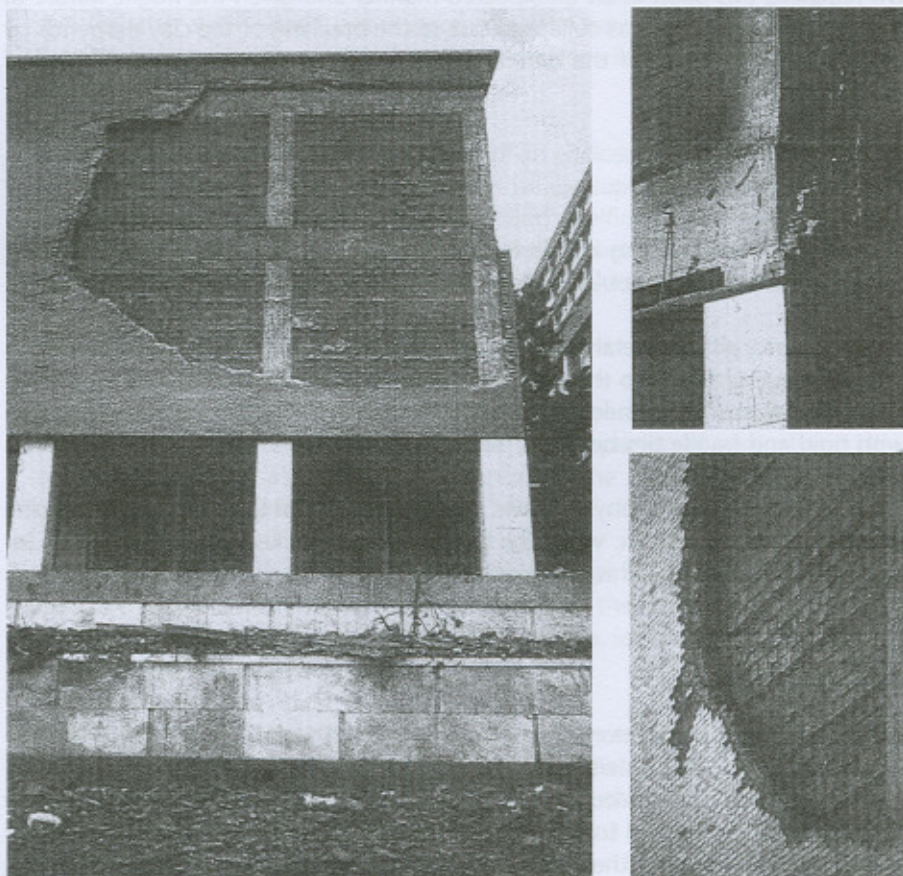
Figure 6.

Three storey public building with portalled ground floor built over 35 years ago. One Sunday when the air was still a panel/section of west-facing brickwork collapsed without fatal consequences. The collapse has led to the questioning of the building system employed (Fig. 6)

After many years without incident this construction suddenly became inoperative and caused the fragile collapse of the wall.

The wall has clay brick perpend or ties which initially worked perfectly, and hence the many years that the building has been operative, However, with time various circumstances have arisen which have caused the brick tie system to fail.

The western facing brickwork has been more vulnerable to temperature change caused by exposure to sun.

The facing clay brickwork has become excessively hot or cold depending on the prevailing weather and has not been able to bear the temperature changes in each brick. As this brickwork is laid with perpends or header bricks between the two leaves, each one of these has been subject to constant temperature changes between the interior and exterior of the building.

The metal support has probably been yielding over the years due the combined effect of the creep in the concrete together with the taughtening of the curved steel bars which have progressively been loaded as the horizontal layer of brick started to split. This led to the gradual tensing and stretching of the bars with the ensuing lowering of the hanging lintel.

This combination of effects has reached a critical moment as the lintel hanger system has not had sufficient inertia and the lintel has turned in such a manner as to threaten the collapse of the outer layer of brickwork.

On reaching this point in an unexpected manner and given the fragile nature of the wall, the brickwork has collapsed due to the breaking of the clay perpends by shear stress as a result of the differential settlement between the two leaves of brickwork.
