CRACK CONTROL IN LONG CLAY WALLS WITH BED JOINT REINFORCEMENT

Josep Mª Adell¹, Concha del Rio²

Tests carried out under natural conditions in two Spanish cities: Pamplona and Toledo

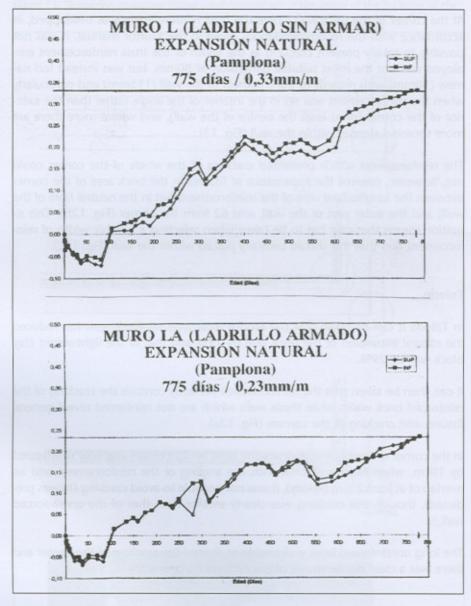
Figure 10. Graph showing natural expansion of long brick walls in Pamplona. Unreinforced brickwork.

The brick walls have expanded 0.335mm/m while the reinforced brick walls have increased 0.235mm/m.

From this it can be taken that the reinforcement has reduced the expansion of the brick wall by 30%.

In Pamplona it can be taken that the Murfor truss type reinforcement has reduced the natural expansion of the brick wall by 30% (Fig. 10) (Fig. 11) and that of the lightweight clay block wall by 33%.

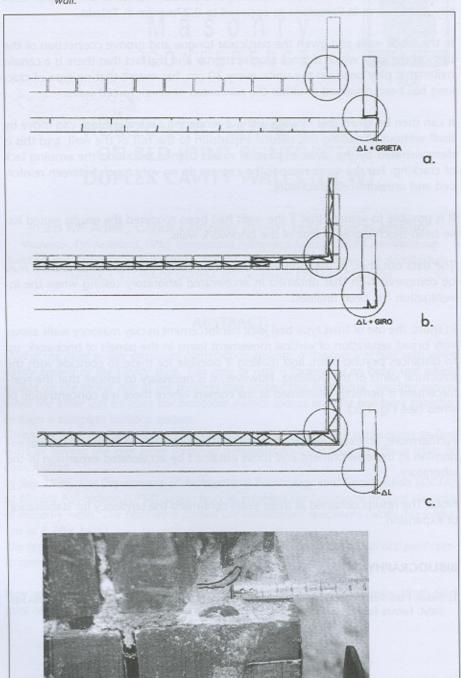
Figure 12. Graphic illustration of the behaviour of Long Brick Walls.

It can then be taken that the reinforcement perfectly controls the cracking of the reinforced brick walls, while those walls which are not reinforced reveal general fissures and cracking at the corners (Fig. 12a).

At the corner of the brick wall where the truss reinforcement was overlapped, in accordance with the recommendations given in the Murfor manual, it was not possible to totally prevent cracking as the width of the truss reinforcement employed was not the most suitable dimension of 80mm, but was instead too narrow (50mm) with regards to the thickness of the wall (115mm) and particularly when the reinforcement was set in the interior of the angle rather than the exterior of the corner (or at least the centre of the wall), and where more there are more torsional stresses within the wall (Fig. 13).

The reinforcement which prevented cracking of the whole of the corner could not, however, prevent the appearance of fissures in the brick area of the corner between the longitudinal wire of the reinforcement (set in the neutral fibre of the wall) and the outer part of the wall, and 62 from the corner (Fig. 12b). This situation means that care has to be taken when selecting a suitable width of reinforcement and that this should centrally placed within the wall (Fig. 12c).

- a. Unreinforced wall: cracking in corner by displacement and generalised cracking.
 b. Wall with incorrectly placed corner reinforcement. Cracking at corner by turning.
- c. Correctly reinforced wall without cracking.

Figure 13. Illustration indicating corner reinforcement set in the centre of the thickness of the wall.

In short: the use of truss type bed joint reinforcement in clay masonry walls allows very broad separation of vertical movement joints in the panels of brickwork, up to distances beyond 30m, and making it possible for these to coincide with the structural joints of the building. However, it is necessary to ensure that the reinforcement is perfectly positioned at the corners where there is a concentration of stress (see Fig. 12c).
