6m SPAN LINTELS TESTS ON A NEW WALL PI-BRACKETS TYPE

SUMMARY

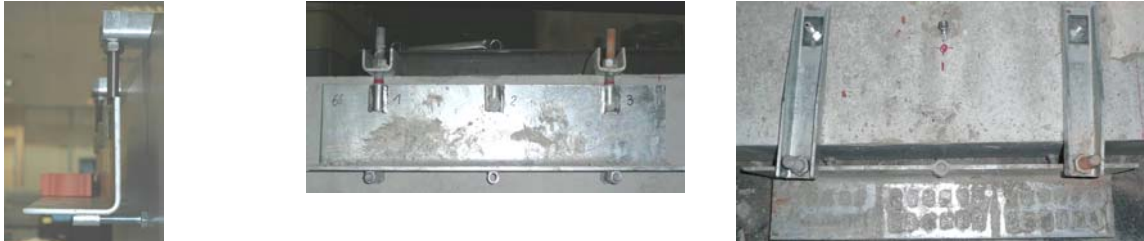
Figure 4 a) Side view of Halfen-AllWall Pi-Bracket with its vertical (Z) and horizontal (Y) adjustments; b) Frontal view; c) View of bracket supporting the first brick in the lintel course.

With this new support, the load of masonry panels in any type of brick or blockwork, may be transferred to the wall supports by means of the braced arch effect provided by reinforced masonry, in accordance with Spanish Murfor Manual calculations and as a result of this new type of patented support (Figures 4a, b and c).

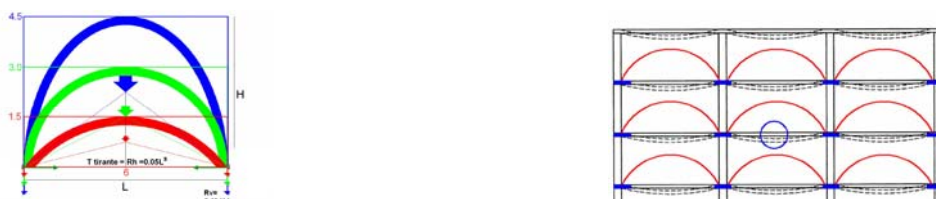
Figure 5 a) Braced arches of different heights all fitted with the same section of steel bracing; b) Braced masonry facing wall set on a framed structure and using the arch effect.

The reinforcement between spaced supports is the same regardless of the height of the arch supported, as the thrust provided by the arch at its base depends on the span and not on the height when considering the load as that of its deadweight: the same bracing is then valid for both reduced linteled arches or raised wall lintels (Figure 5.a). When walls are supported at regular intervals coinciding with the vertical supports, the enclosure assembly no longer loads the slabs and, instead, transfers loads through the vertical supports and prevents defects associated with the deformation of the slabs and their ensuing transfer to the facing wall (Figure 5.b).

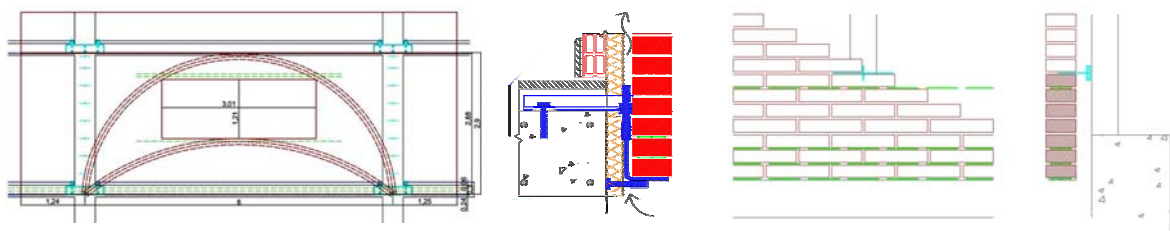
Figure 6. Possible reduced or circular arches for the same bracing set between 2 supports
Figure 7. Vertical section of the Pi-Bracket, showing continuous, insulated+ventilated cavity.
Figure 8. Vertical section through the centre of the brick panel at the same level of support.

This has the advantage that in facing walls with openings, the arch formed within the masonry may pass both above and below the opening in a panel of standard floor height and only requires 2 or 3 reinforcements of 5 or 4mm diameter for distances between supports of 6 to 7 m respectively (Figure 6).

The section of the wall support for this type of facing wall has all the necessary adjustment components to provide suitable cavity width and continuous insulation in front of the slab and incorporates reinforcement between the 6m spaced supports (Figure 7). Furthermore, the section of this same wall in the centre of the panel clearly reveals that it is not necessary to support the masonry on account of the “braced arch” effect (Figure 8).

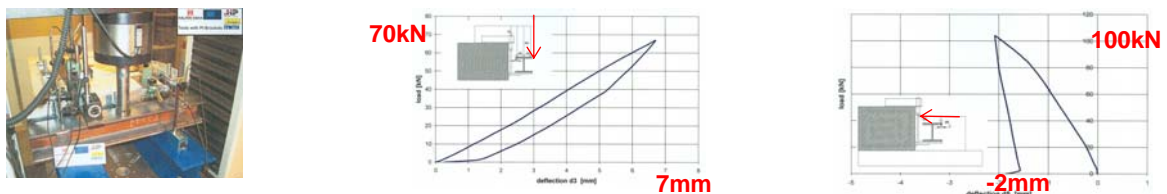
Figure. 9. Testing of one of the three Halfen-AllWall Pi-Bracket prototypes in Germany.

Figure. 10. a) Graph of vertical deformation “d3”; b) Graph of horizontal deformation “d5”.

The test consisted of vertically loading the brackets by a jack set on an “I” beam profile which uniformly distributed the load on the bracket until reaching the maximum working values and, at the same time, verifying whether support strains were within admissible limits (Figure 9).

Three wall brackets were tested in their normal working position with the brackets fixed on the top of a slab and reacting against the face of the slab. The deformation (strain) recording method is shown in the figures where the values “d0”, “d1”, “d2” and “d3” (Figure 10a) refer to the vertical deformations and values “d4” and “d5” refer to horizontal deformations produced by the moment generated on the application of the load (Figure 10b).

The first two tests reached loads of 66kN, without plastic deformation, and revealed the horizontal reaction of the bolts in the concrete. On reaching maximum deformation load there was evident rotation of the bracket. The third test reached a maximum load of 104kN and caused cracking in the concrete around the supports of the “U” angles and around the horizontal reaction bolts.

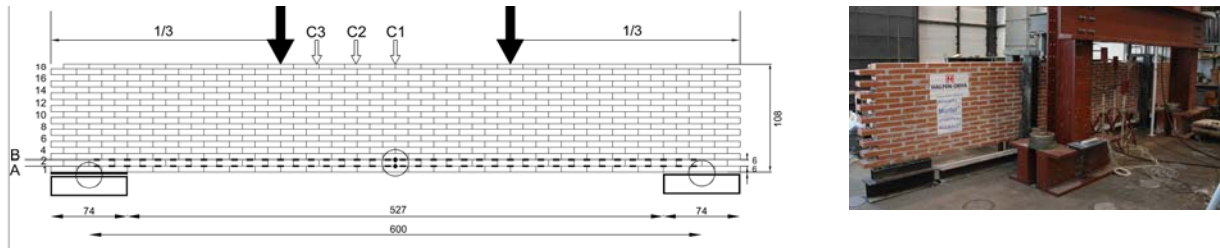
Figure 16: a) 1st brick 6m span lintel, simply braced, with A and B Murfor (inox. B800)
b) 1st brick lintel of 6.75x1.08x0.115m, set on Pi Brackets, ready for testing.

The walls were tested for vertical bending using 2 hydraulic jacks with the same load, set at one third span distances from the edge of the wall, in order to simulate the effect of uniform load equivalent to its deadweight. Vertical strain gauges were set on the wall in addition to two extensometric gauges in the centre of each Murfor “A” and “B” truss-type bed joint reinforcement forming the bracing to the brick panel (Figure 16 a y b).

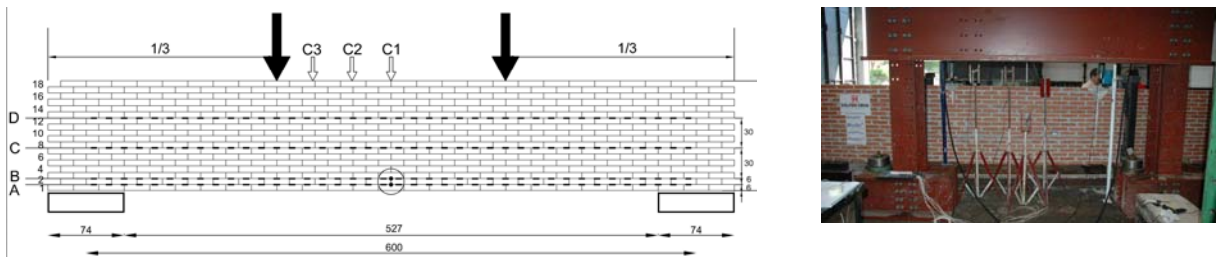
Figure 17: a) 2nd brick 6m span lintel, simply braced, with A, B, C and D Murfor (inox. B800)
b) 2nd brick lintel of 6.75x1.08x0.115m, set on Pi Brackets, ready for testing.

The 2nd lintel was built with perforated brick of standard quality (M-10) with M8 mortar, reinforced with bed-joint reinforcement (“A” and “B”) and additional uniform reinforcement (“C” and “D”) of Murfor RND.5/S-80 stainless steel (B-800), with brickwork set directly on wall brackets at both sides (Figure 17 a and b).

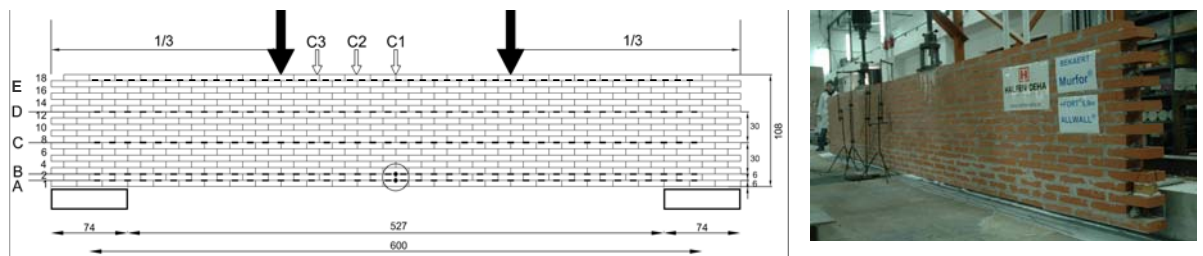
Figure 18: a) 3rd brick 6m span lintel, simply braced, with A, B, C, D and E Murfor (galva. B 500)
b) 3rd brick lintel of 6.75x1.08x0.115m, set on Pi Brackets, ready for testing.

The 3rd lintel was built with perforated brick wall of standard quality (M-10) with M8 mortar, reinforced with bed-joint reinforcement (“A” and “B”) and additional uniform reinforcement (“C”, “D” and “E”) of Murfor RND.5/Z-80 standard galvanized steel (B-500), with brickwork set directly on wall brackets at both sides (Figure 18 a and b).

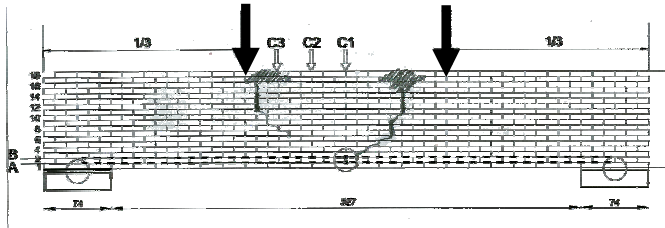
Figure 19. Failure due to horizontal compression of the 1st tested brick lintel (2 inox. B 800).
Figure 20. View of collapsed brickwork after testing: a) At the left jack; b) At the right jack.

The test on the 1st wall (with only 2 stainless steel bed joint reinforcement as a brace) (inox. B800) was satisfactory in accordance with the safety margins established for the materials. The first lintel to be tested failed by compression in the direction of the bed joints in the upper central third close to the jacks, without reaching the breaking stress of the reinforcement of the lower brace (Figure 19). The crack in the centre of lintel in the tensile area barely exceeded 1 mm and the overall cohesion of the wall was retained (Figure 20 a and b).

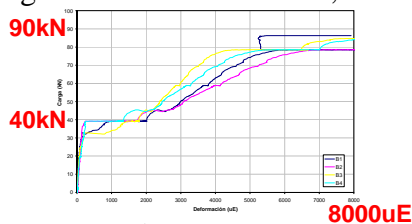
Figure 21: 1st Test: a) Stress-strain diagram of extensometric gauges (B1, B2, B3, B4) set on reinforcement; b) Readings of the vertical displacement load recorded by LVDTs (C1, C2, C3).

The stress strain diagrams corresponding to the extensometric gauges set on bed joint reinforcement (B1, B2, B3, B4, B5) of the 1st test, show that these work almost in unity until the loss of mortar bond, and do not indicate potential reinforcement failure (Figure 21.a). The LVDTs placed to record vertical strain (C1, C2, C3) deformed together until reaching the cracking stress of the brickwork, at around 40kN loading on each of the two jacks (Figure 21.b).

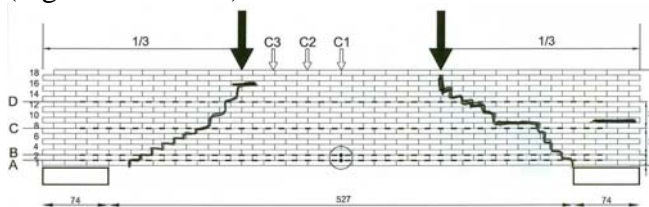
Figure 22. Type of shear failure of the 2nd tested brick lintel (4 Inox. B 800).
Figure 23. View of collapsed lintel after testing: a) left shear crack; b) right shear crack.

The test on the 2nd wall (with 4 stainless steel bed joint reinforcement) (inox. B800) was totally satisfactory in accordance with the safety margins established for the materials. The 2nd lintel tested failed by shear in 45° direction from the laterals supports, without reaching the breaking stress of the reinforcement of the lower brace (Figure 22). The crack in the centre of lintel in the tensile area barely exceeded 1 mm and the overall cohesion of the wall was retained (Figure 23 a and b)

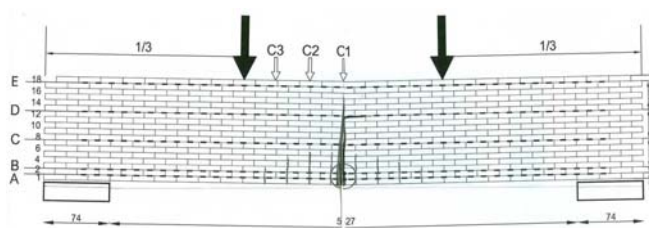
Figure 24. Shear failure of the 3rd tested brick lintel (5 galva. B 500).
Figure 25. View of collapsed lintel after testing: a) central crack; b) reinforcement detail.

The test on the 3rd wall (with 5 stainless steel bed joint reinforcement) (galva. B500) was totally satisfactory in accordance with the safety margins established for the materials. The 3rd lintel tested failed by traction in the bottom in the centre of the lintel, reaching the breaking stress of the reinforcement of the lower brace (Figure 24) (Figure 25 a and b).

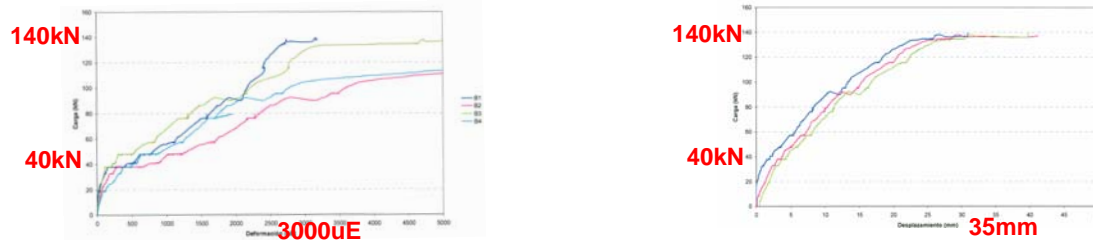
Figure 26: 3rd Test: a) Stress-strain diagram of extensometric gauges (B1, B2, B3, B4) set on reinforcement; b) Readings of the vertical displacement load recorded by LVDTs (C1, C2, C3).

The stress strain diagrams corresponding to the extensometric gauges set on bed joint reinforcement (B1, B2, B3, B4, B5) of the 3rd test show that these work almost in unity until the loss of mortar bond, and do not indicate potential reinforcement failure (Figure 26.a). The LVDTs placed to record vertical strain (C1, C2, C3) deformed together until reaching the cracking stress of the brickwork, at around 140kN loading on each of the 2 jacks (Figure 26.b).
